**SHERIFFDOM OF GRAMPIAN, HIGHLAND AND ISLANDS AT INVERNESS**

**[2024] FAI 25**

DETERMINATION

**CLIVE HENDRY**

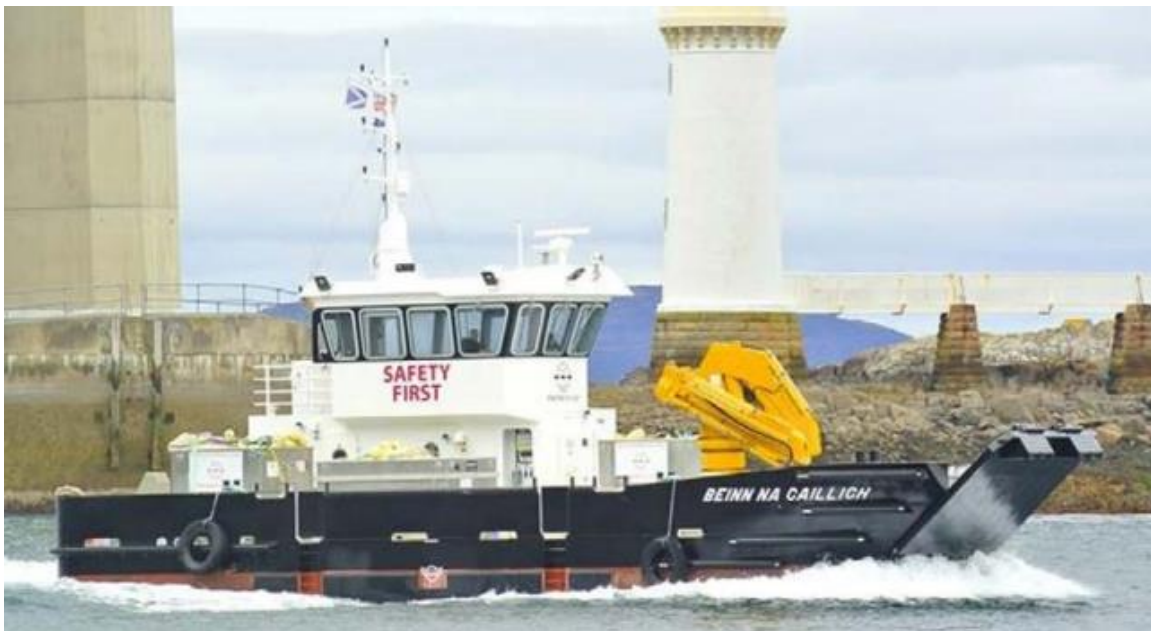
[35] The *Beinn na Caillich* is the vessel which was involved in the fatal incident. A photograph of the vessel is shown below.

It is a workboat, constructed in the Netherlands, with two years in service as at February 2020. It is fitted with a hydraulic bow ramp and is used for ferrying personnel, materials, plant and equipment between locations. It is crewed by two MOWI employees, a master and deckhand. Mr Palmer was the master on 18 February 2020. It is nineteen metres long, with a beam of seven metres, a displacement of around ninety five tonnes and an open working deck.
