SHERIFFDOM OF TAYSIDE, CENTRAL AND FIFE AT DUNDEE

[2024] FAI 46

DETERMINATION

ANDREW CALDER SINCLAIR

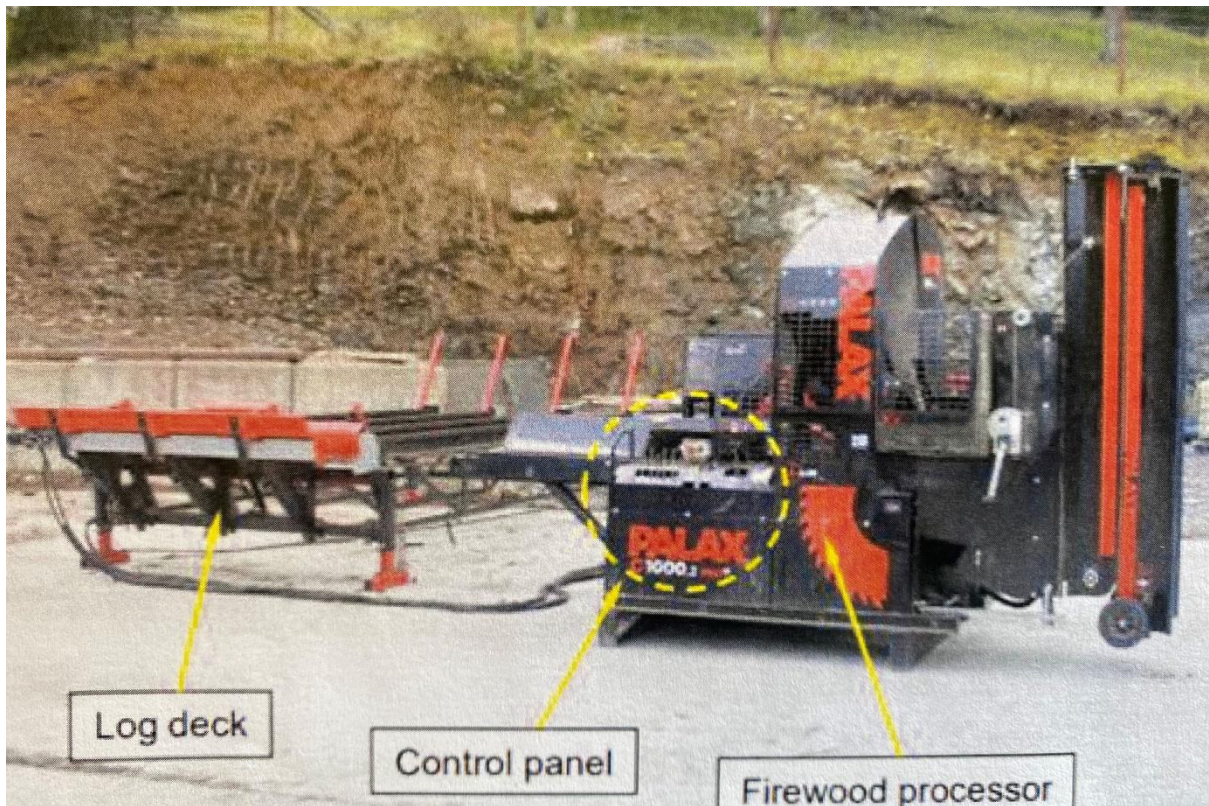
[19] The Firewood Processing Machine comprises of two separate components namely, the log deck and the Firewood Processing Machine, shown below in an image from DK Logs (production number 2 with the output conveyor (far right of image) in a folded inoperable position).

[20] The log deck (image above) consists of three main parts:

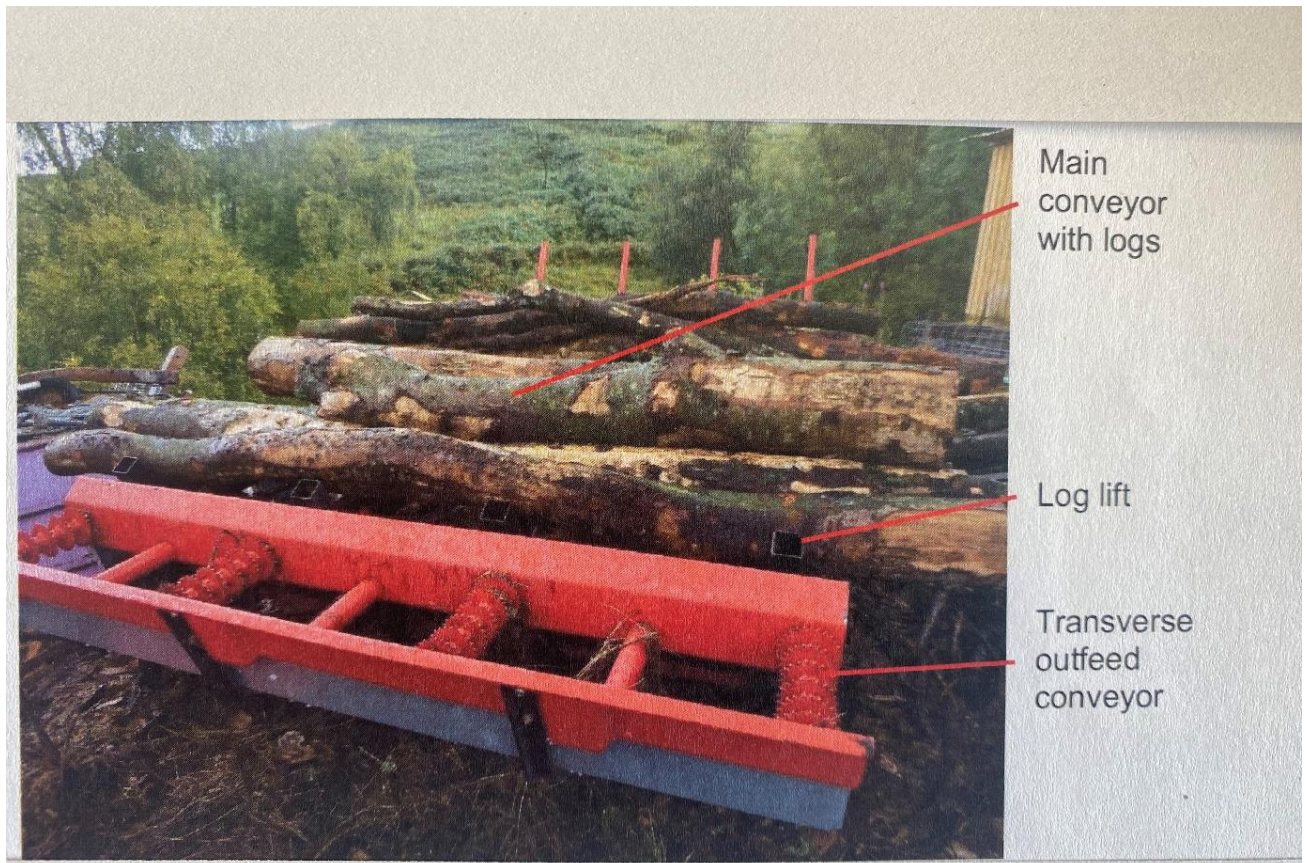
[21] The three main parts of the log deck can be seen in the image below, said image is taken from page 8 of David Gostick's report (production number 6 for the Procurator Fiscal Depute).

[34] The investigation found that Mr Sinclair's clothing (a green top) had become entangled in the toothed cogs of the transverse conveyor of the log deck. For Mr Sinclair

to have become entangled the toothed cogs have to have been operational. The toothed cogs are hydraulic. The operation of the toothed cogs can only be done by an operator at the control panel of the FPM.

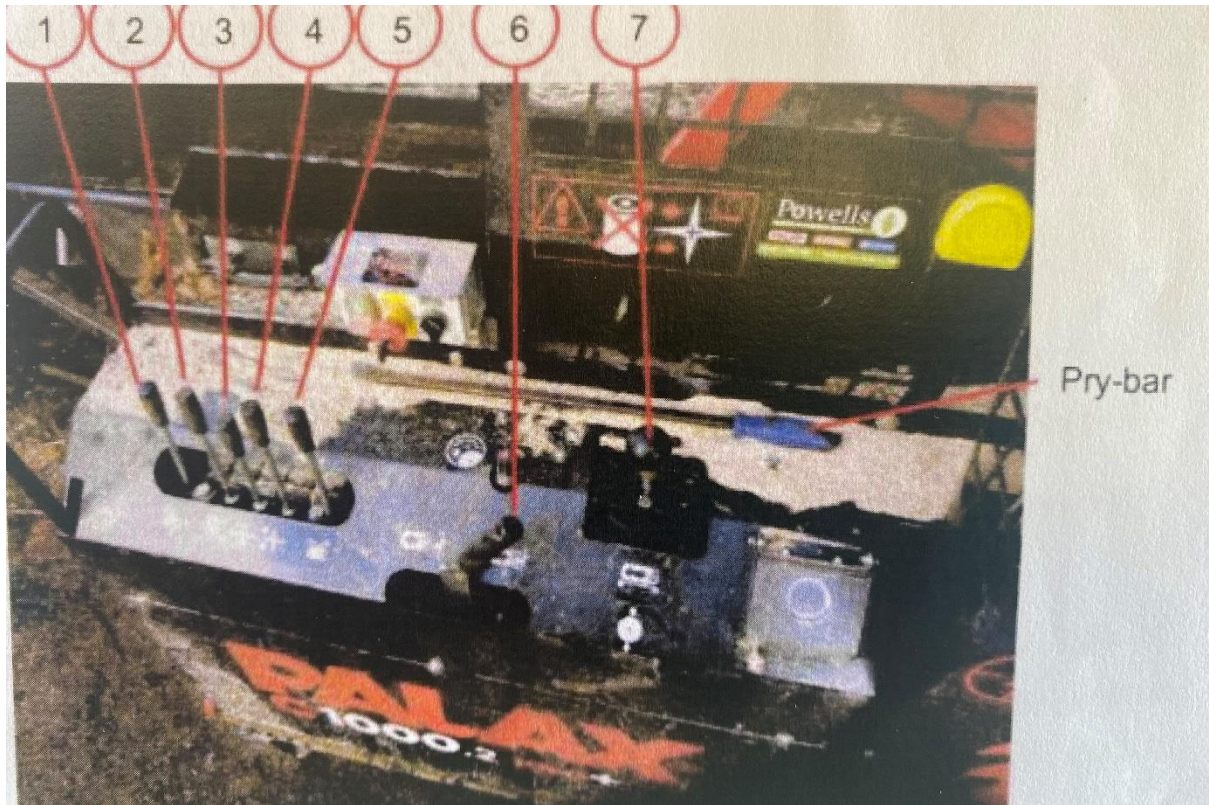
[24] All of the operating controls for the FPM (and the log deck) are located in the middle front of the machine (labelled “control panel” in the image of the log deck and FPM above) and shown in greater detail in the image below.

[25] The controls on the FPM are described as “hold to run” in other words the operator must apply a force to one or more of the levers to operate the machine, the type and situation of the control panel are designed to ensure a safe system of working in combination with the interlocking guard preventing access to the processing area. The FPM is designed to be operated by a single operator again to ensure other persons are not present when the controls are used.

[36] The investigation found evidence to support their working theory that someone had “jammed” the hold to run controls. A blue handled pry-bar was found lying on top of the control panel for the FPM (pry-bar can be seen in the image of the controls *supra*). Mr Gostick was able to jam the pry-bar in the hold to run controls, leave the control panel and approach the log deck.
