SHERIFFDOM OF LOTHIAN AND BORDERS
IN THE ALL-SCOTLAND SHERIFF PERSONAL INJURY COURT

[2021] SC EDIN 65

JUDGMENT OF SHERIFF CHRISTOPHER DICKSON

Edinburgh 30 August 2021

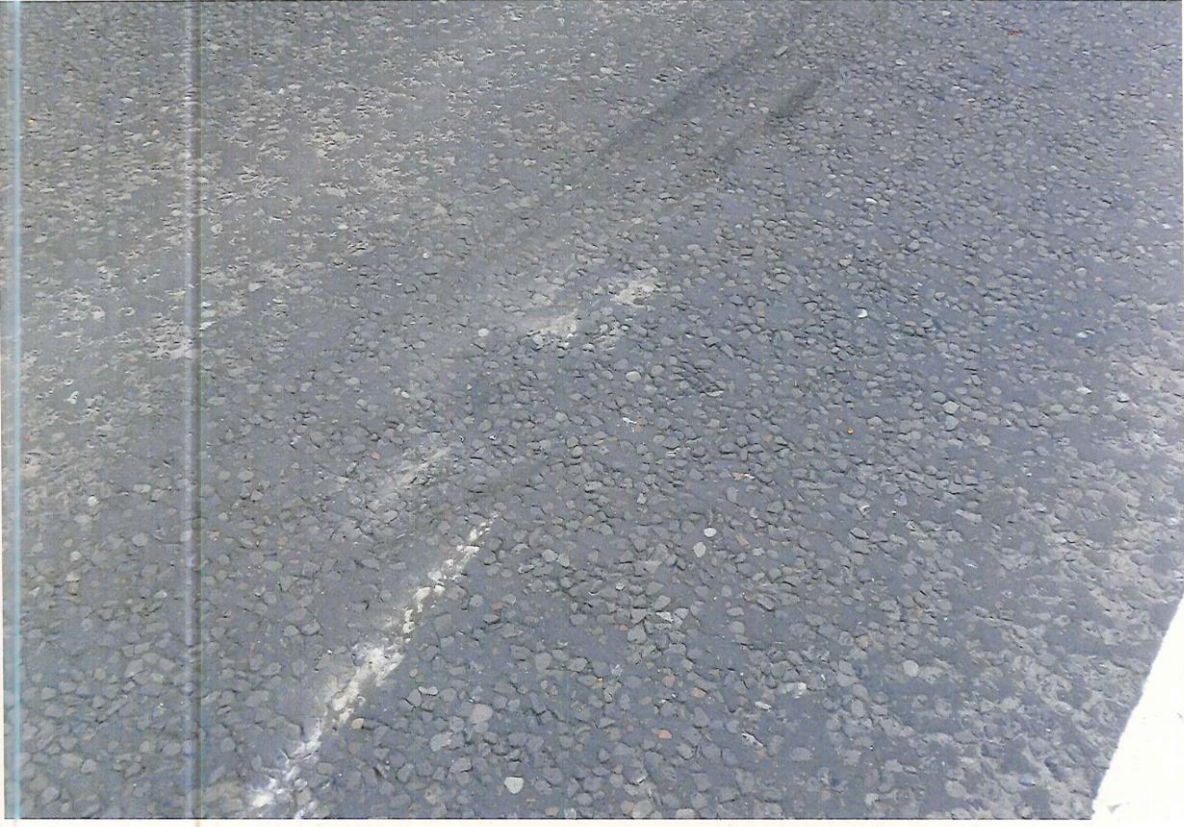
Photograph A111

3. A111 - the white centre line is in the bottom right of the photograph. The photograph shows white marks on the road which would be caused by metal coming into contact with the road. These are the scrape marks Pc Dewar was referring to in his statement being approximately 100 metres from the area of the second collision. The photograph also showed possible tramline tyre marks, which Pc Dewar understood to be caused by the outer edges of a punctured tyre. Pc Dewar thought these tyre marks were caused by either the wheel rim of the audi or the wheel rim of the trailer. He thought they may be from trailer as they were not particularly wide but he could not say for certain. Pc Dewar would not have ignored the scrape marks and thought that this photograph showed where the first collision occurred but he could not be sure. He thought that he had worked backwards from the resting position of the toyota and trailer to the area of the second collision and this led him

to believe that the photograph showed the scrape marks and the tyre marks in the eastbound lane. He thought that the scrape marks had come from the trailer and the tyre marks were a continuation of the trailers tyre marks shown in A109. Pc Dewar noted that the trailer had a slight overhang over the trailer's tyre and thought that it was possible that the trailer was on the centre line. Pc Dewar's belief, based on the road markings, although he stressed he was not a qualified collision investigator, was that there had been a coming together between the audi and trailer near the centre of the road. Pc Dewar conceded that there were other photographs that showed tramline marks that related to the audi and accepted that photograph A111 may in fact show the westbound lane but his memory was that photograph A111 showed the eastbound lane.

1. A111 – Mr Mottram considered that this photograph had been taken looking west and showed: (i) light coloured gouge marks in the westbound lane, which Mr Mottram considered to be the likely point where the first collision occurred; (ii) the white centre line to the right bottom hand corner of the photograph; and (iii) a tramline tyre mark, which Mr Mottram considered showed the commencement of the audi long tramline tyre mark. Mr Mottram noted that the tramline tyre mark shown on photograph A111 seemed to be at a similar angle to the audi long tramline

tyre mark which was shown on photograph A128 (which was taken looking to the west) and A112 (which was taken looking to the east). Mr Mottram noted that one would expect first to see evidence of the impact (in the form of the gouge marks) and then, after a very short period to allow for the deflation of the front offside tyre of the audi, the commencement of the tramline mark (Mr Mottram noted his opinion on this point was supported by Mr Gilfillan at paragraph 42 of this report – see paragraph 16 above). This would not have occurred the other way around (because it would indicate a deflation before the impact, which made no sense) and fortified Mr Mottram's view that photograph A111 was looking west at the westbound lane. Mr Mottram explained that the gouge marks would have been caused from metal or alloy from either the trailer or the audi coming into contact with the road.

Mr Mottram noted that Pc Dewar was clear that the gouge marks shown in A111 were 100 metres from the second collision and Mr Mottram considered that they were in the westbound lane for the reasons given above.

on photographs A112 and A128 but I also noted that each photograph was taken from a different perspective. In the end I came to the conclusion that Pc Dewar was mistaken as regards photograph A111 showing the eastbound lane and that the audi long tramline tyre mark did indeed flow from the gouge marks located in the westbound lane for the following reasons. First, Pc Dewar explained, when he was referred to his police statement, that he had prepared his police statement the day after the accident whilst his memory of events were fresh and clear. His statement included the following passage:

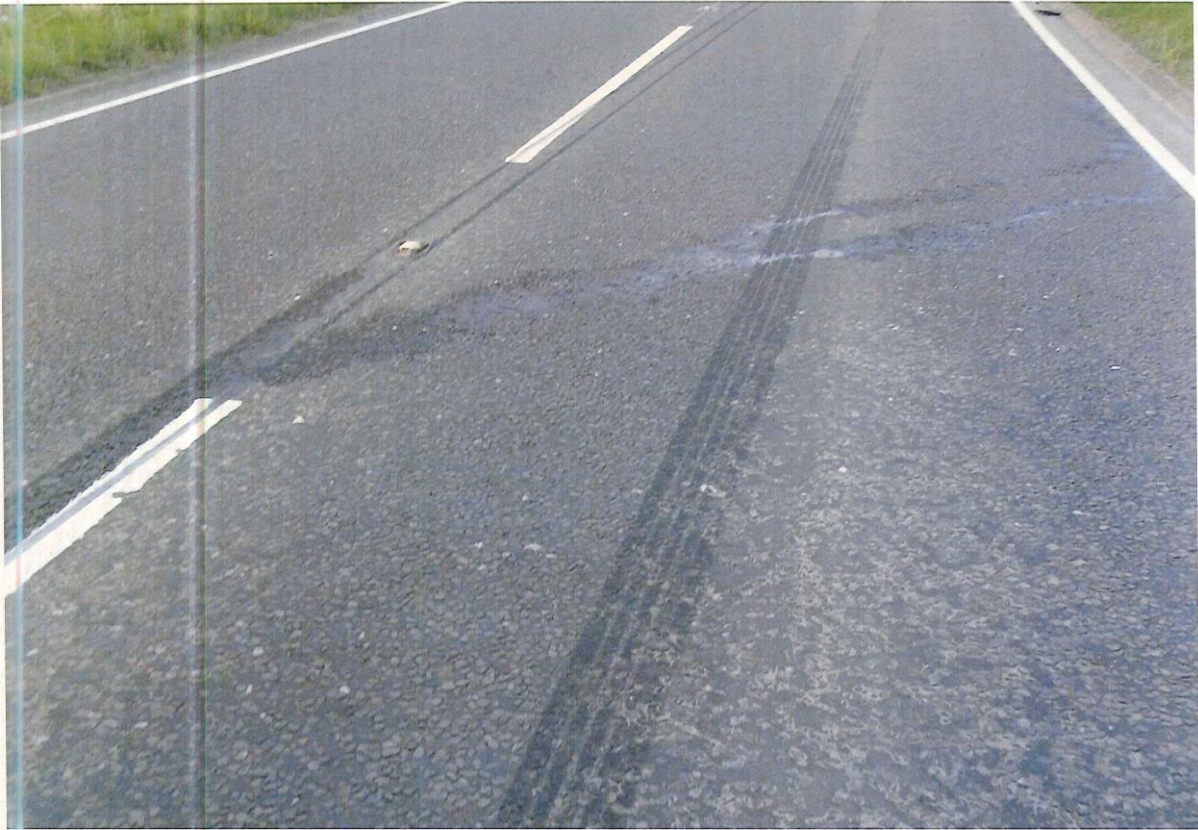
Photograph A112

4. A112 – this photograph showed the westbound lane to the right of the photograph and the eastbound lane to the left. Pc Dewar agreed that the audi had made the audi long tramline tyre mark following the first collision with the trailer. This photograph showed the audi long tramline tyre mark travelling from the westbound lane (the audi's correct lane), across the white centre line and into eastbound lane. Pc Dewar could not recall where the audi long tramline mark began. The photograph also showed a skid mark from the audi's front nearside tyre in the westbound lane. Pc Dewar noted that it was unusual to see a skid mark from a modern car because most have ABS which prevents a wheel locking up.

line. The audi long tramline tyre mark then ran from the westbound lane, across the white centre line and into the eastbound lane. Pc Dewar accepted that the audi long tramline tyre mark would extended further back on the westbound lane. Pc Dewar noted the debris next to the solid nearside line and advised that this indicated that the accident would have occurred further back (meaning further east on the road).

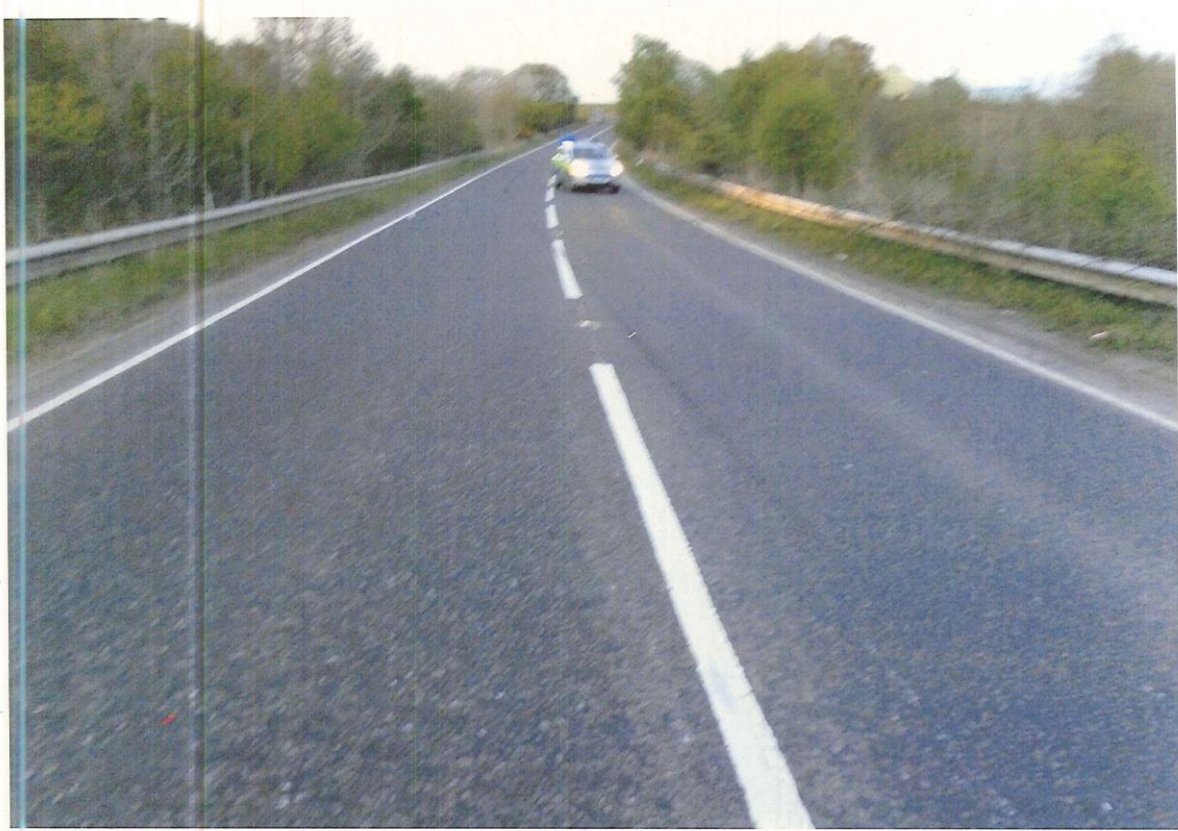
Photograph A113

(b) Mr Loat thought it was possible for both the audi and trailer to make tyre marks at the point of the first collision without there being a need for an interval between the point of the first collision and the making of the tyre mark. Mr Loat considered that the tyre mark in the westbound lane, shown in photograph A113, was caused by the front offside tyre of the audi, during the first collision, as the tyre was punctured and deflated. Mr Loat, considered that there was no physical evidence to show that the trailer had encroached into the westbound lane nor was there any physical evidence that the toyota had been overtaking. Indeed if the toyota had been overtaking and returning to the eastbound lane, Mr Loat would have expected the trailer to be at more of an angle and any collision at such an angle would have probably caused both the audi and the trailer to rotate. Mr Loat accepted that if the tyre mark in the westbound lane, shown in photograph A113, was made by the audi it was nevertheless at an angle that was diverging from the white centre line and moving towards the nearside of the westbound lane. However, Mr Loat explained that he considered that the tyre mark in westbound lane, shown on photograph A113, continued in a straight line and there came a point when it turned into the audi long tramline tyre mark, due to the pursuer locking the front offside wheel of the audi by applying emergency braking (effectively the audi long tramline tyre mark was a continuation of the tyre mark in the westbound lane shown in photograph A113). Due to this part of the road being a curved left hand bend, what had happened was that the tyre mark in the westbound lane, shown in photograph A113, had initially diverged from the white centre line

[85] I did not consider that Mr Loat's opinion of how the first collision occurred was convincing. I considered that photograph A113 was a blurred photograph that was difficult to make out what it showed. I considered, on a close analysis of that blurred photograph, that it was possible to see a gap on the white centre line between the tyre mark in the westbound lane and the tyre mark in the eastbound lane, but I considered that it was also possible that that gap was caused by the blurring of the photograph. I did not, however, consider a depression on the white centre line was a plausible explanation for the gap between the tyre marks. Mr Loat's opinion was that the first collision occurred on the white centre line and resulted in both the offside tyres of the trailer and the front offside tyre of the audi making instantaneous tyre marks. I did not find this convincing for the reasons explained by both Mr Mottram and Mr Gilfillan (namely that there would be a short passage of time between the first collision occurring and the tyre marks being left on the road).

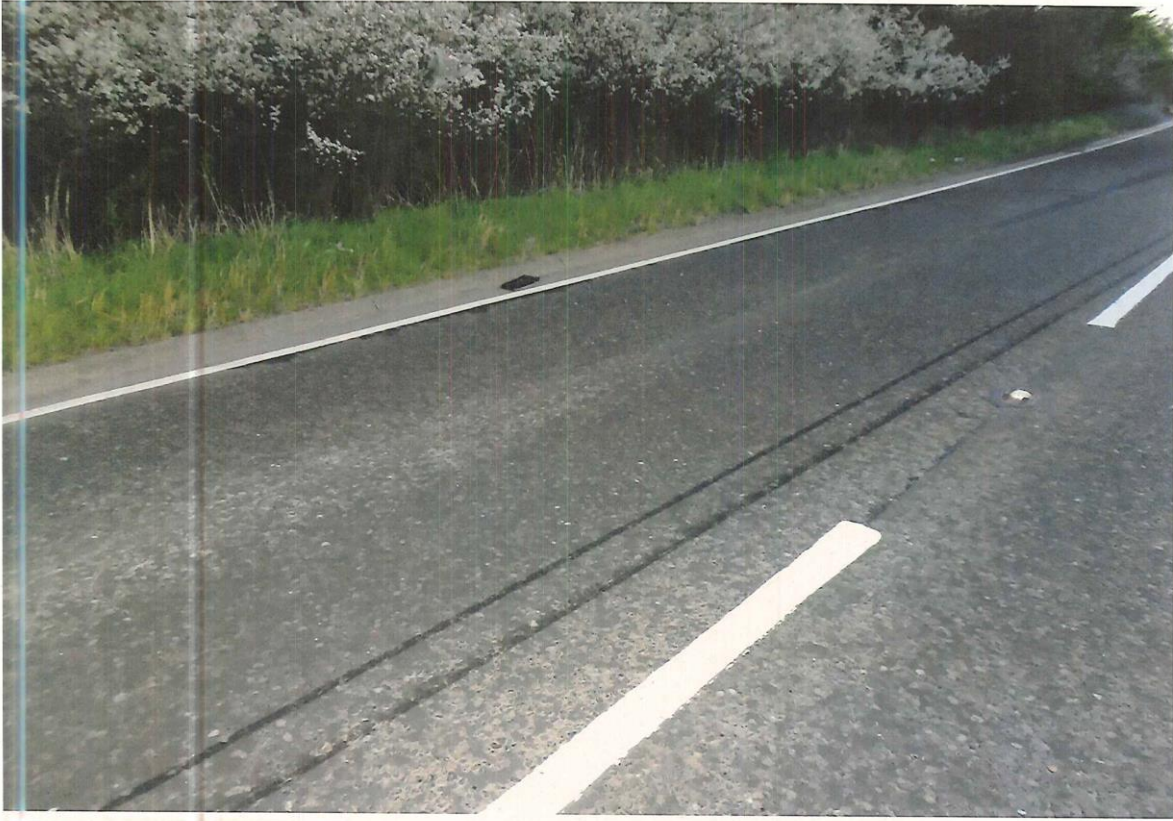
Photograph A128

2. A128 – Mr Loat considered this photograph was taken looking west and showed the audi long tramline tyre mark and the audi nearside skid mark. The audi long tramline tyre mark had been made by the front offside tyre of the audi running on the rim of the wheel. The audi's front offside wheel had also been locked, which was consistent with emergency braking. This same tyre had made the tyre mark in the westbound lane on photograph A113. The audi nearside skid mark resulted from the audi nearside front wheel being locked. That could only have occurred if the audi's ABS had failed or was faulty. Mr Loat considered that the audi's ABS probably failed during the first collision. Mr Loat noted that, generally, if ABS is working properly it could produce padded tyre marks. However, in this case there was no physical evidence of the type of tyre marks that would be produced by the
