SHERIFFDOM OF LOTHIAN AND BORDERS AT EDINBURGH  
IN THE ALL-SCOTLAND SHERIFF PERSONAL INJURY COURT

[2019] SC EDIN 91

JUDGMENT OF SHERIFF ROBERT D M FIFE

SHEILA VARNEY

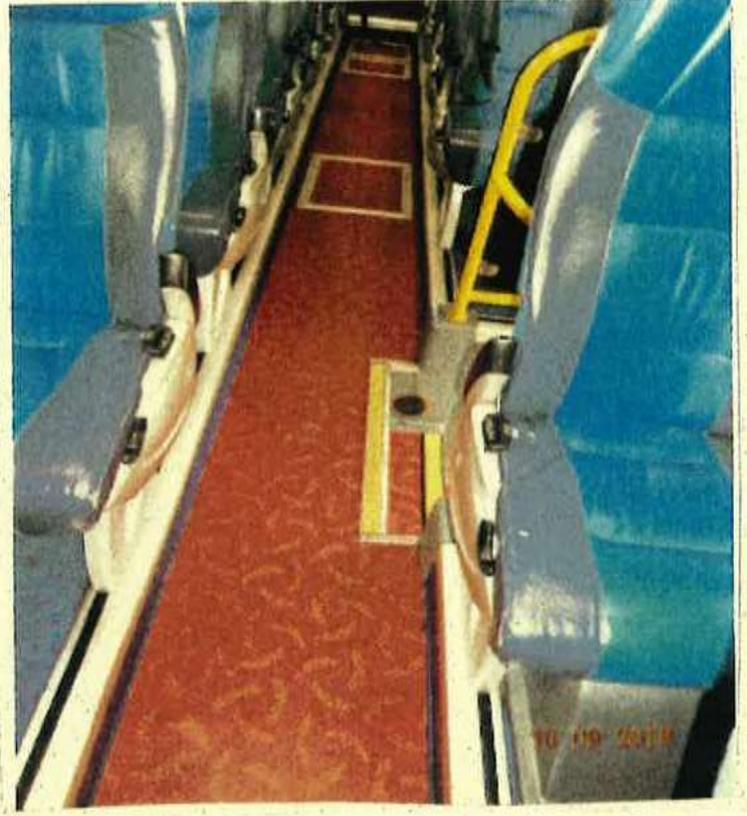
Photograph 3 – Gangway looking to rear of omnibus and Emergency Exit

[13] The gangway narrowed from 520mm to 432mm, measured at floor level, being from the edge of the elevated seat platform, to the edge of the top step of the stairs. The edges of the ingress measured approximately 88mm. The ingress was a hazard for passengers.

[20] The sides of the ingress at the top step were not marked with yellow nosing. There was a metal edge strip on each side. There was no warning sign to passengers of the presence of the ingress.

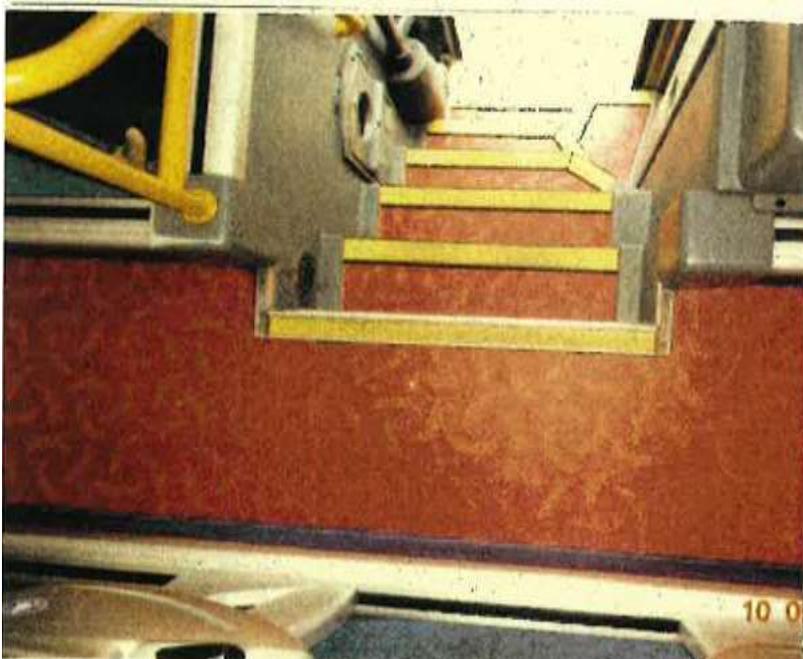
Photograph 4 – Emergency Exit Steps

[18] The floor of the gangway was coloured red. The nosing at the front edge of the top step at the ingress was a plastic, yellow coloured, strip (“yellow nosing”).

[19] The yellow nosing extended over the width of the top step. Its purpose was to mark the leading edge of the step for anyone using the emergency stairs.
