SHERIFFDOM OF LoTHIAN AND BORDERS AT EDINBURGH
IN THE ALL-SCOTLAND SHERIFF PERSONAL INJURY COURT

[2020] SC EDIN 44

JUDGMENT OF SHERIFF ROBERT D M FIFE

GORDON WALLACE

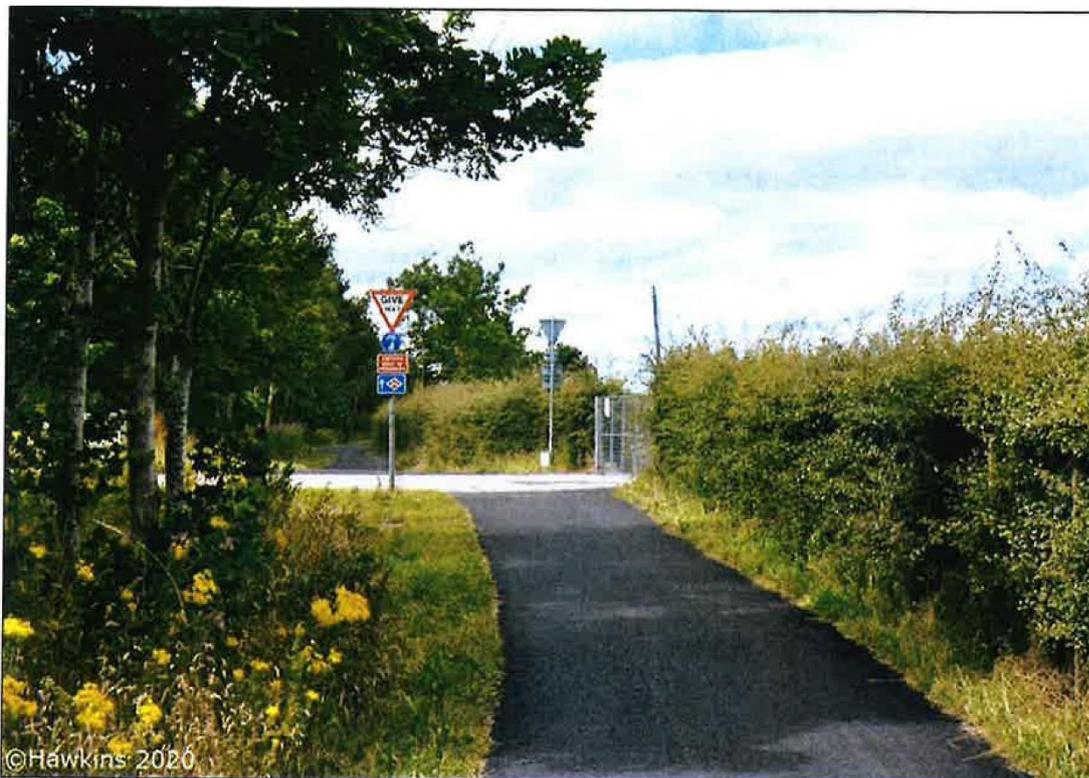
Photograph 11 in the report by Ms Holland, production 6/1, at page 80 of the joint bundle of productions (finding in fact 11)

Photograph 11: The approximate view available from the centre of the cycle track from a distance of about 30 metres.

- (12) The pursuer had a view of the Give Way sign, the access road and the entrance/exit gates to the Balgove Course from a distance of at least 30 metres from the access road. That view is shown in photograph 11 in the report by Ms Holland, production 6/1, at page 80 of the joint bundle of productions: see the appendix to this judgment.

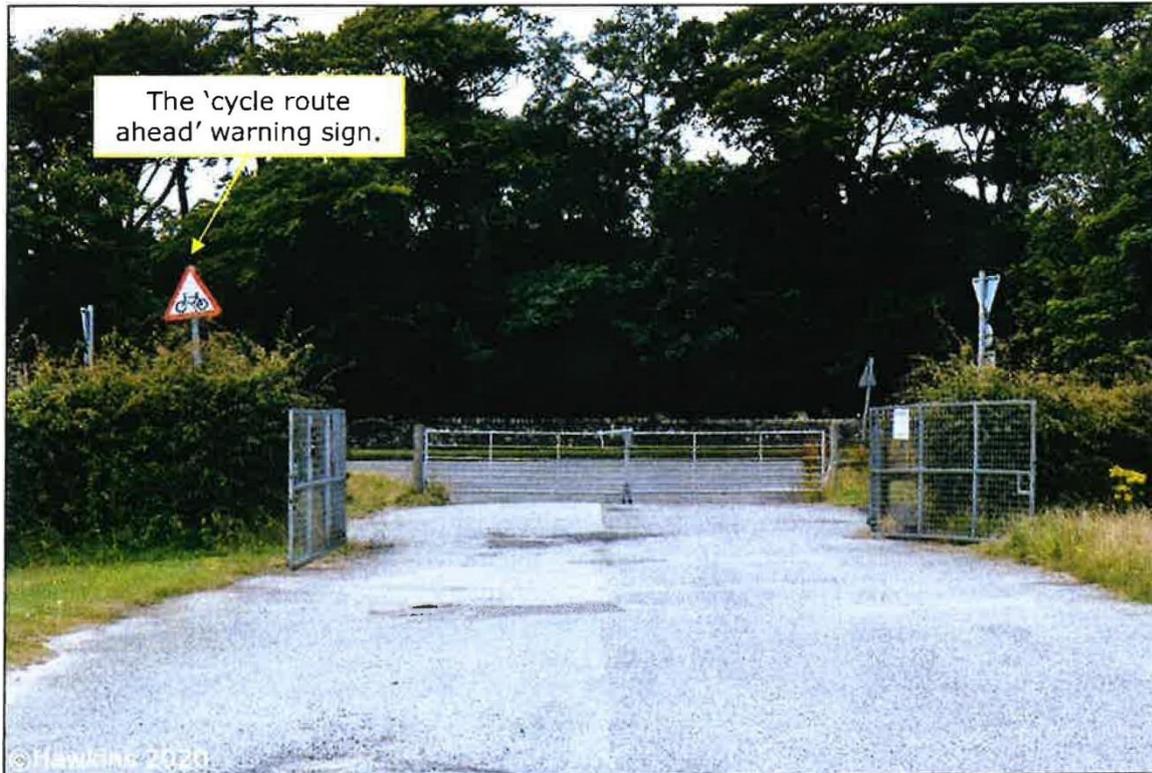
Photograph 4 in the report by Ms Holland, production 6/1, at page 76 of the joint bundle of productions (finding in fact 18)

Photograph 4: The approximate view available to a car driver from the centre of the access road from a distance of about 20 metres.

access road, heading towards the exit gates and the A91. That view is shown in photograph 4 in the report by Ms Holland, production 6/1, at page 76 of the joint bundle of productions: see the appendix to this judgment.
